Central-Locking Motor Repair

One of the car's doors caused an intermittent failure of the central-locking system.

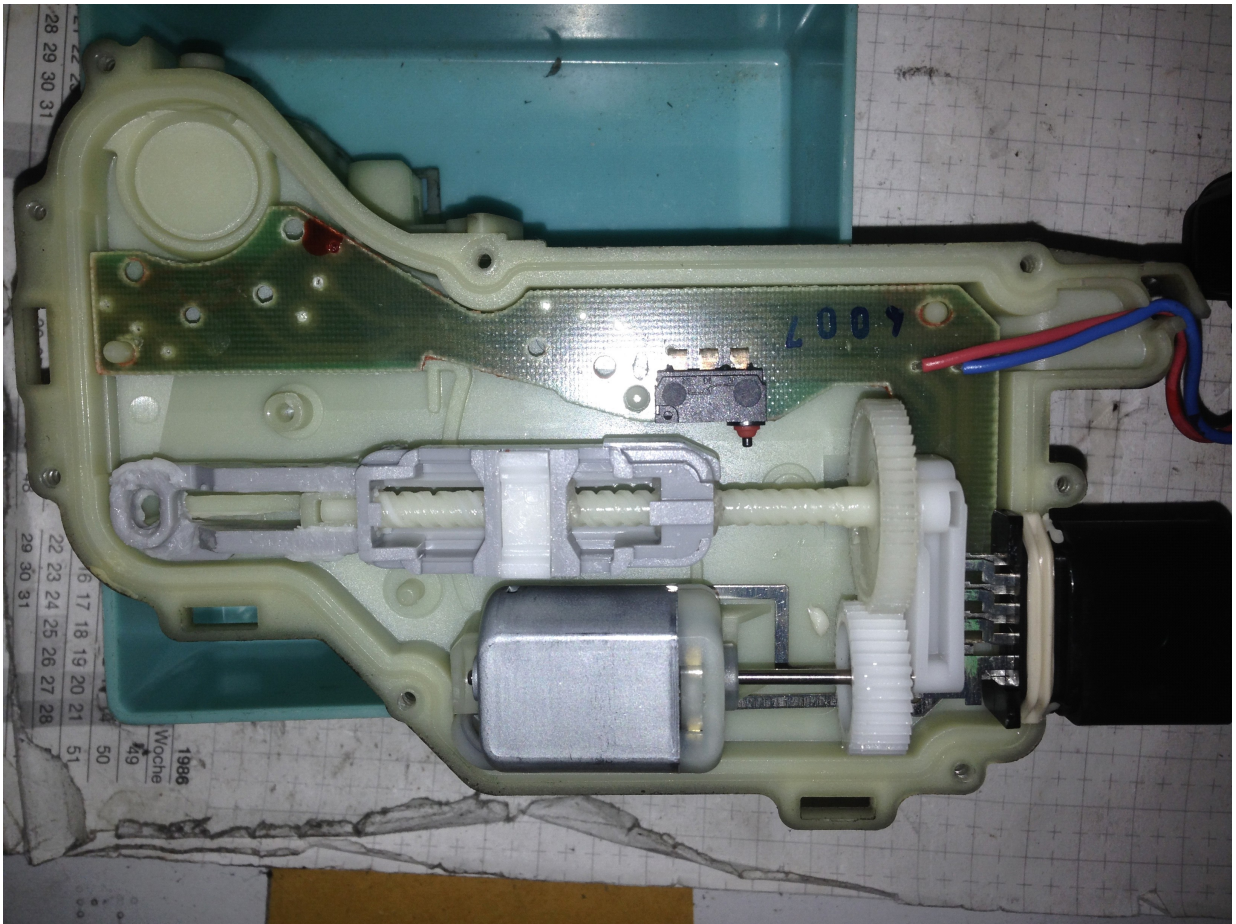
In a 2007 Volkswagen Rabbit, the passenger door's central-locking mechanism looks this way:

It's just about the motor at the bottom - a Mabuchi FC-280PD-20150. This motor is not thermistor protected. It showed very erratic DC resistances of several hundred Ohms. Once removed from the structure, I could however run it easily in both directions from 12 V DC.

This motor is custom-made (<https://www.mabuchi-motor.com/product/knowledge/classification/designations.html>), a data sheet not available. Because of the integral gearwheel, replacement is available in Brazil only (<https://www.armazemautomotivo.com/busca/motor-mabuchi-fechadura-trava-eletrica-vw-golf-passat-polo/er-404> et al). I could not make them yet communicate in English, so I had to repair my motor instead.

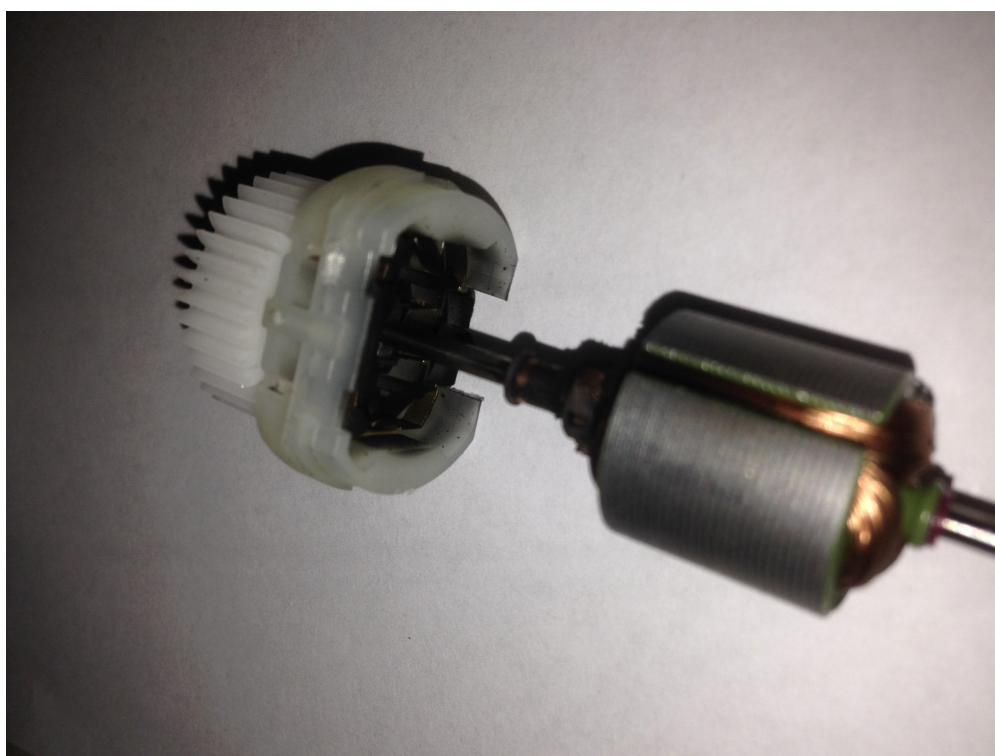
Once open, the commutator room revealed its malaise:

So I clamped the rotor carefully (not knowing how soft the shaft is) into a slowly rotatable chuck and applied a glass-fiber eraser (the one partly visible beneath the chuck) to the revolving commutator

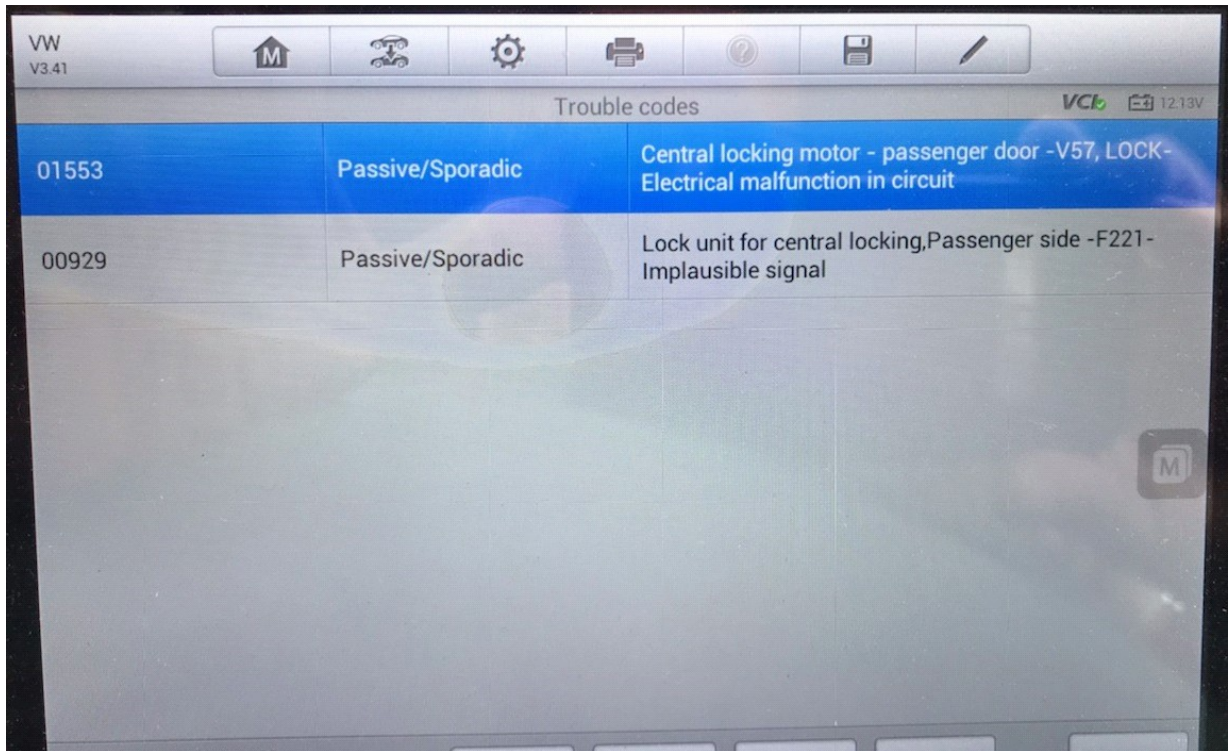
OBDII reports the damage as 01553 and 00929 DTCs:
