Central-Locking Motor Repair

One of the car's doors caused an intermittent failure of the central-locking system.

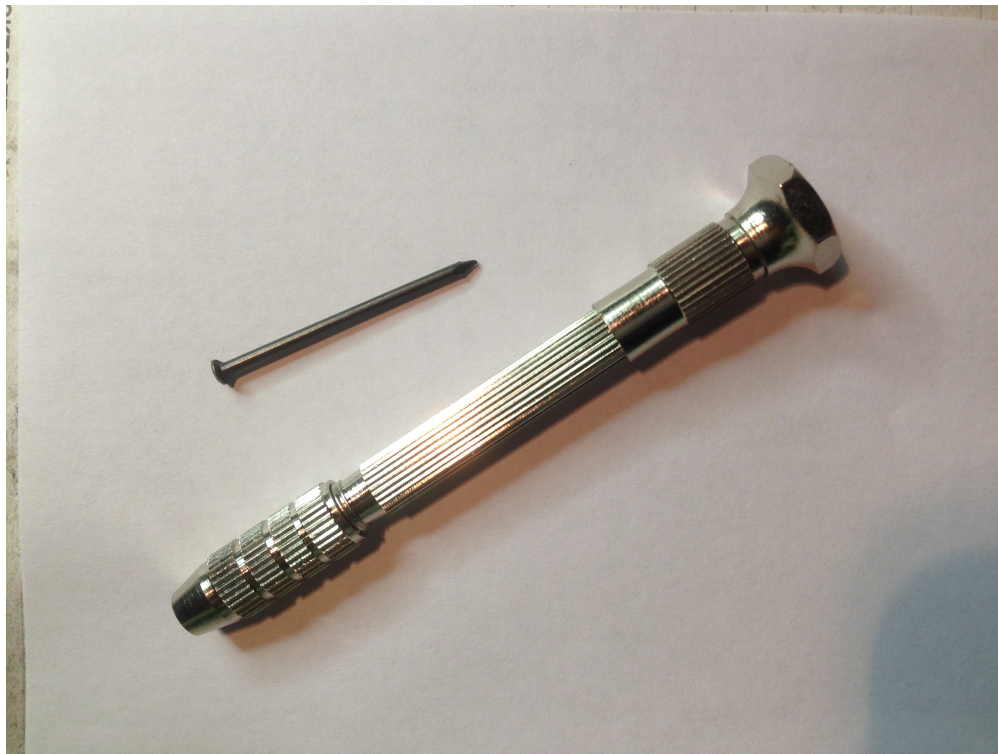
Several predecessors reported trouble while making the two tabs release the motor's body. So I prepared a special hook to pry them out, taking a hardened-steel nail and a pin vise.

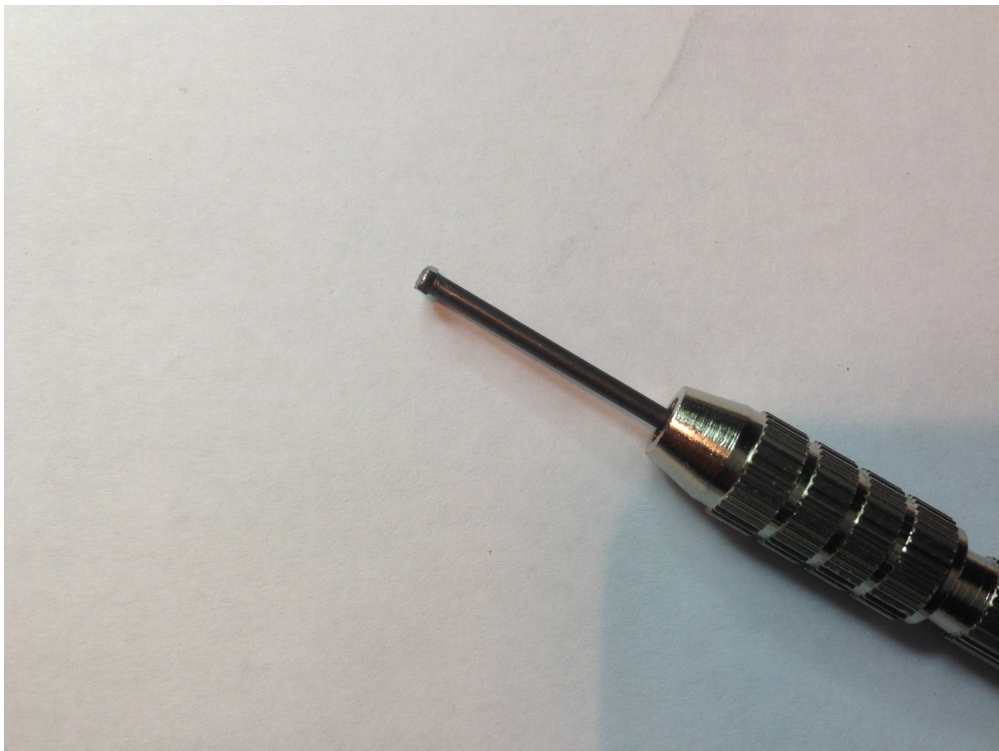
and just narrowed the nail's head to fit into the notches where the tabs reside:

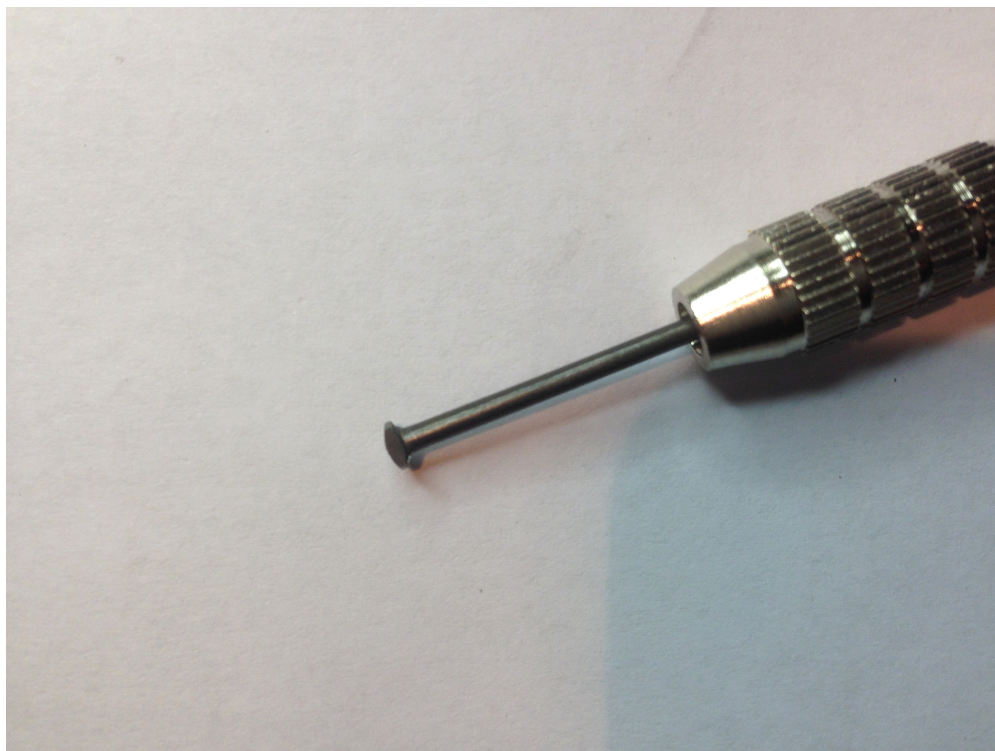
So I got pretty much the intended hook

and could pry the tabs a bit away - however assisting with kind of a wedge between the nail's head and the wall of the notch. Fortunately I needed just two hands for that, but a further pair of hands for a photo was not available.
